MERRIMACK RIVER BASIN
ANDOVER NEW HAMPSHIRE

BRADLEY LAKE DAM

NH 00034

PHASE I INSPECTION REPORT NATIONAL DAM INSPECTION PROGRAM

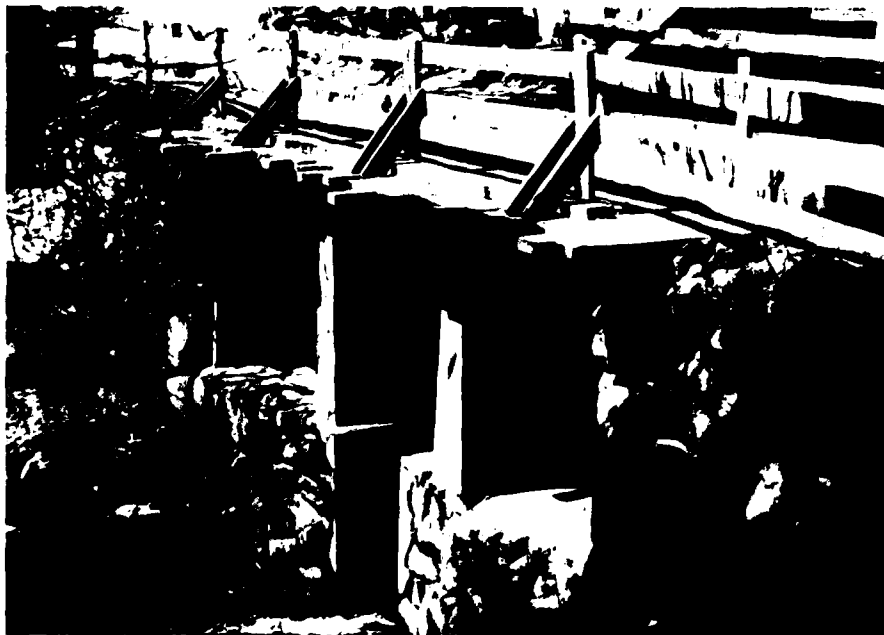
The old spillway was a stone masonry structure. The downstream face of the old spillway can be seen in Photo No. 22. No seepage was observed from the downstream face of the spillway.

PHOTO NO. 22 - View of downstream face of outlet
works from left bank.
